**SIXTH LAKE DAM**  
HAMILTON COUNTY, NEW YORK

**NY 318**  
**PHASE I INSPECTION REPORT**  
**NATIONAL DAM SAFETY PROGRAM**

CONVERSE WARD DAVIS DIXON  
CONSULTING ENGINEERS  
91 ROSELAND AVENUE, P.O. BOX 91  
CALDWELL, NEW JERSEY 07006

11. CONTROLLING OFFICE NAME AND ADDRESS		12. REPORT DATE	
New York State Department of Environmental Con- servation/ 50 Wolf Road Albany, New York 12233		21 September 1978

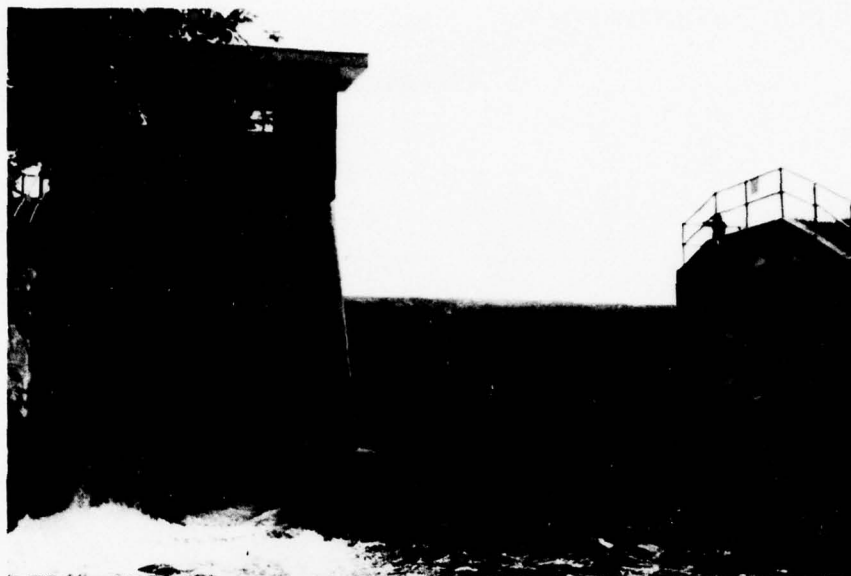
FIGURE 1. DOWNSTREAM VIEW OF SPILLWAY GATE HOUSE STRUCTURE

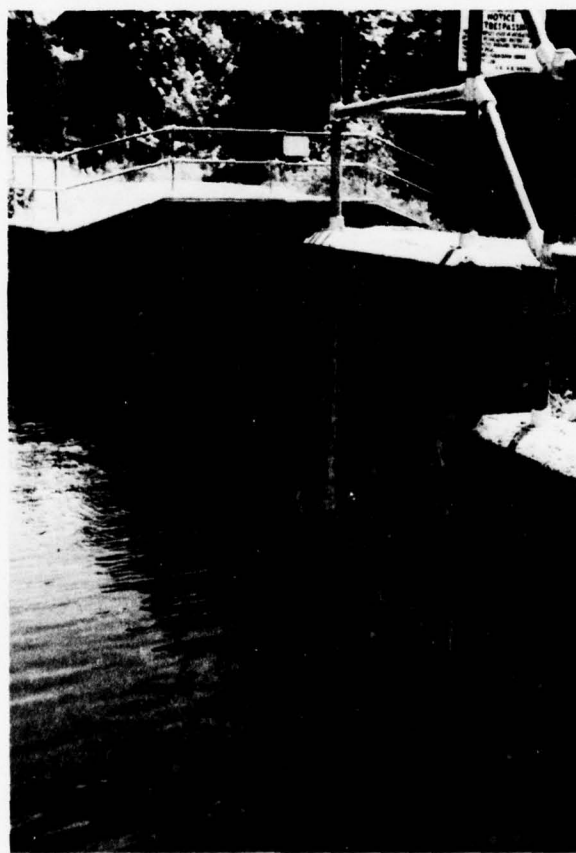
The pool elevation is monitored 6 days a week by a local gatetender of HRBRRD. There is a staff gage to the right of the gate house on the upstream wing wall for this purpose (Fig. 2, Appendix D). The normal operating procedure is to keep the water level of the pool 2 feet below spillway crest elevation during the winter months between November and April, to minimize the effect of ice thrust and to obtain storage capacity for the spring floods. The gates are operated periodically through the winter to keep them from freezing shut.

FIGURE 2. STAFF GAGE

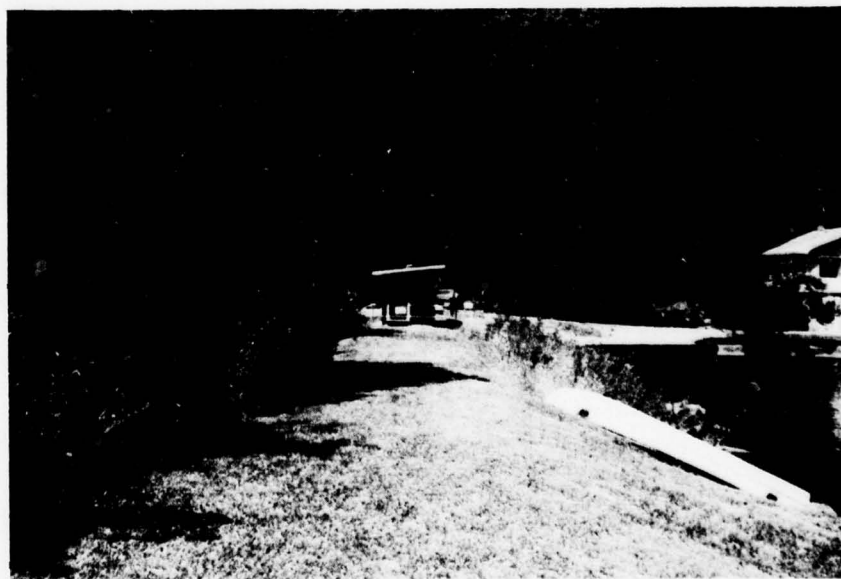
The crest of the left embankment is about 10 feet wide and was covered with well-trimmed grass on the day of the inspection. A pathway on the crest leads to the left side wall of the spillway, which is also the left retaining wall of the spillway/gate house structure. There is a guard rail on the wall to protect the public from accidentally walking off the edge of the embankment (Fig. 4, Appendix D).

FIGURE 4. LEFT EMBANKMENT CREST

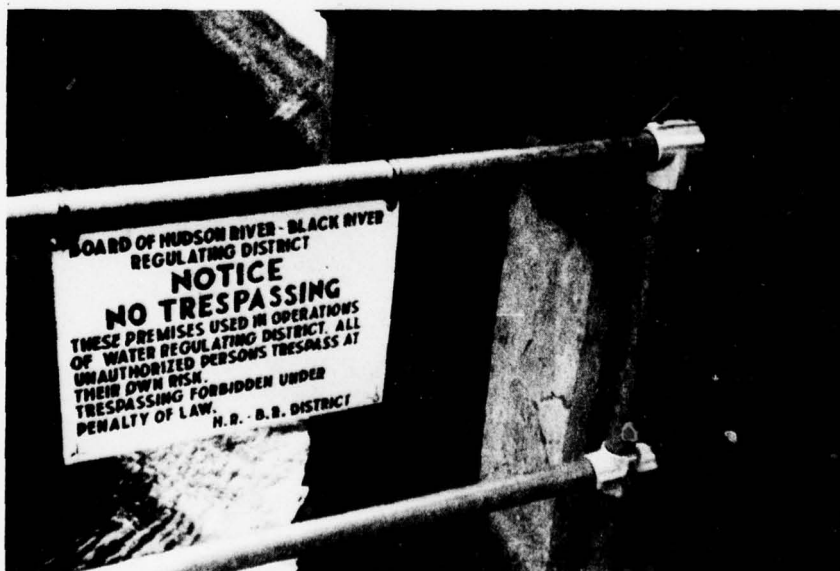
The gate house superstructure is in generally good condition. It is a wood frame structure and has been recently painted. The area around the structure is well maintained and guard rails protect the public from accidentally falling off the retaining walls. No-trespassing signs are clearly displayed (Fig. 12, Appendix D). The interior of the gate house is well lighted and clean. The gate stands are readily accessible and appear to be well maintained (Fig. 13, Appendix D).

FIGURE 12.    GUARD RAIL AND SIGN AT GATE HOUSE

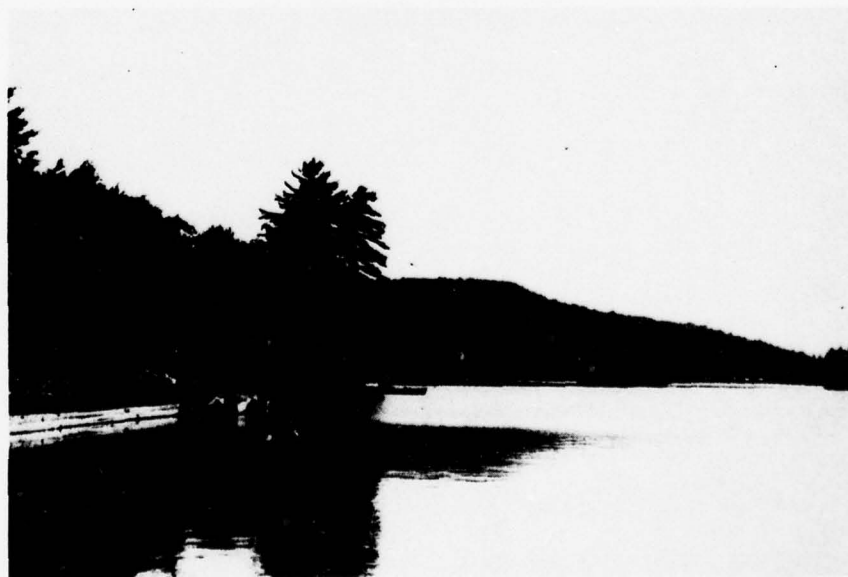
The reservoir area is heavily wooded. Slopes average approximately 1 vertical to 6 horizontal along the immediate shoreline (Fig. 14, Appendix D). They become steeper (about 1 vertical to 3 horizontal) farther inland, especially along the right shoreline. There is no evidence that sedimentation is a problem. The land surrounding both Sixth and Seventh Lakes is zoned primarily for recreational use with some commercial lots. The area is not developing rapidly and the current land usage is not expected to change.

FIGURE 14. RESERVOIR AREA - RIGHT SHORELINE
